Rush Creek Watershed

Ottawa and Kent Counties, MI

Field Surveys
performed by DEQ staff
October and November 2003

SUMMARY OF RUSH CREEK WATERSHED ASSESSMENT KENT AND OTTAWA COUNTY, MICHIGAN

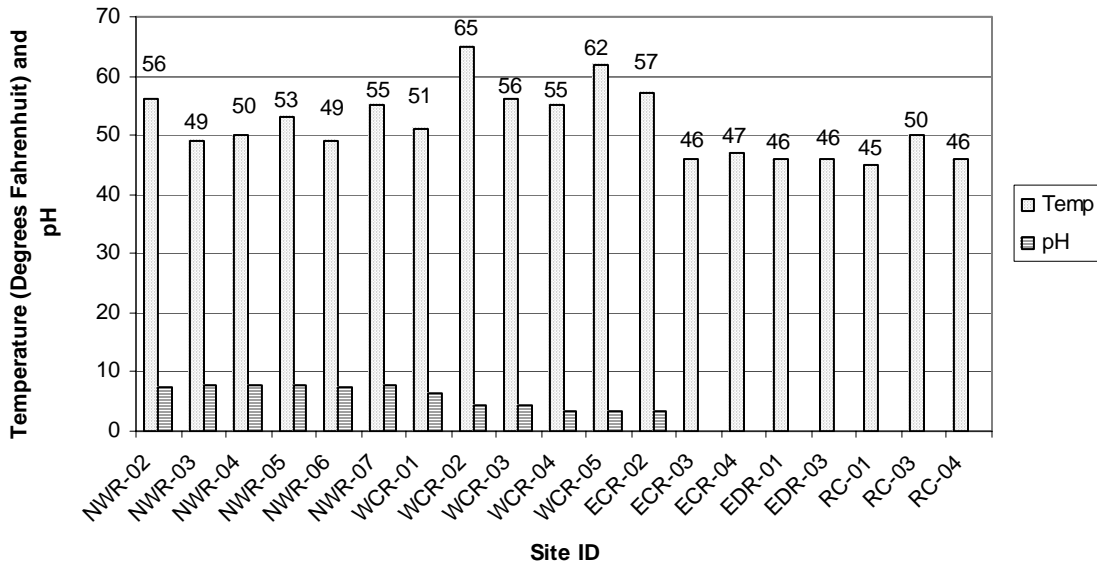
Figure 1. Temperature and pH summary for the Rush Creek Watershed
Note: Some stations lack pH data

Survey locations were assessed in the order of upstream sites (in the headwaters) to downstream sites (towards the mouth). Twenty-four locations, including ten along the main stem of Rush Creek, were measured for temperature and pH. pH values ranged from 3.4 to 7.92, which indicated that the pH meter was probably not working correctly, therefore pH will not be summarized in the following report. Overall the average temperature was 51.7° F, with most stations at either 45 or 46° F. One location, at Quincy Road east of 32nd Avenue, was 65°F which was the highest recorded temperature within the watershed. This comparatively high reading was due to unknown sources.

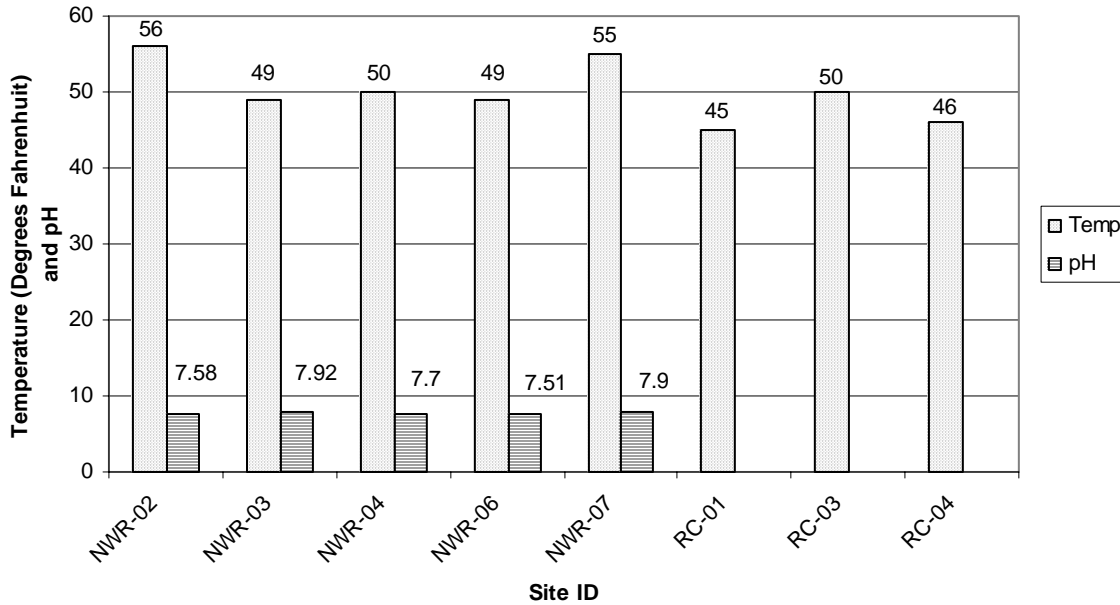
Figure 2. Temperature and pH summary for the mainstem sample locations from the headwaters to the mouth of Rush Creek
Note: some stations lack pH data

conducted during the fall. Maximum air temperatures during the four field days of this survey ranged from 41°F (on November 7) to 68°F (on October 31). Refer to Figure 1 in Attachment B, which depicts the temperature and pH levels at all locations surveyed and to Figure 2, for only those temperatures and pH measurements for the mainstem locations.

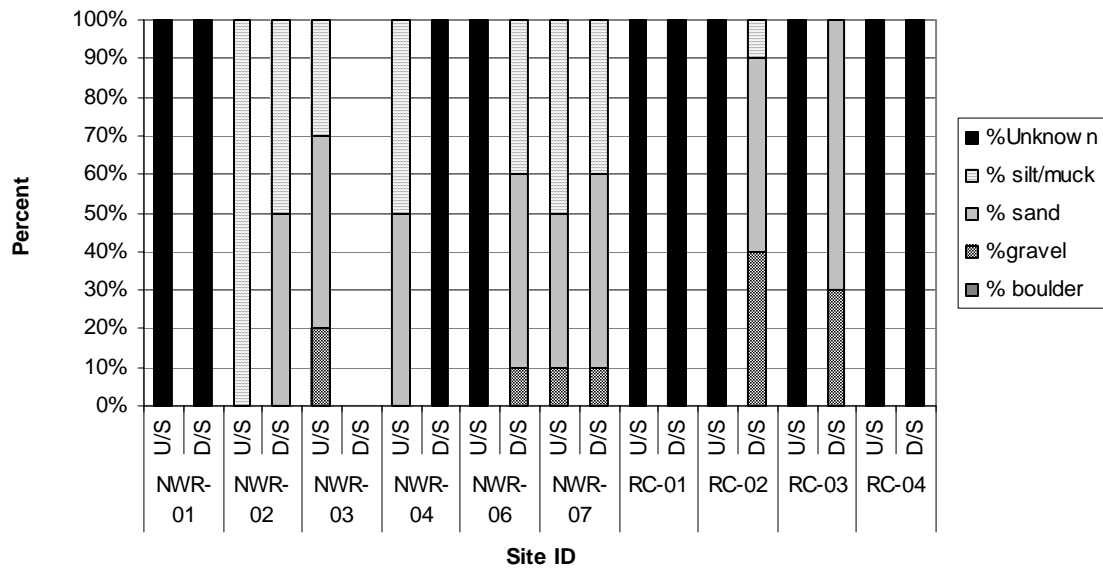
Figure 7. Percent substrate observation for the mainstem sample locations from the headwaters th the mouth of Rush Creek

Substrate was observed and quantified for both the upstream and downstream stretch at each survey location. In all, forty-eight substrate observations were recorded. Substrate type is important when considering habitat suitability for desired species within the system (i.e. trout and other fish species). Cobble and gravel substrates with a low degree of embeddedness are the most suitable for reproduction in many fish species and is important for macroinvertebrates as well. Evidence of silt and sand dominated substrate could indicate problems within the watershed such as erosion and sedimentation. Among the survey locations within the Rush Creek Watershed approximately 10% were dominated (80 to 100% covered) by sand and 17% were dominated silt, detritus or muck. 31% of the sites were unable to be categorized due to turbidity. None of the sites observed appeared to be dominated by cobble or gravel however 27% of the sites had some amount of gravel present (although it was always less than 50%). Refer to Figures 3 through 6 for substrate data for each of the subwatersheds separately. Refer to Figure 7, in Attachment B, for a graph depicting the substrate composition for those survey locations located along the main channel of Rush Creek.

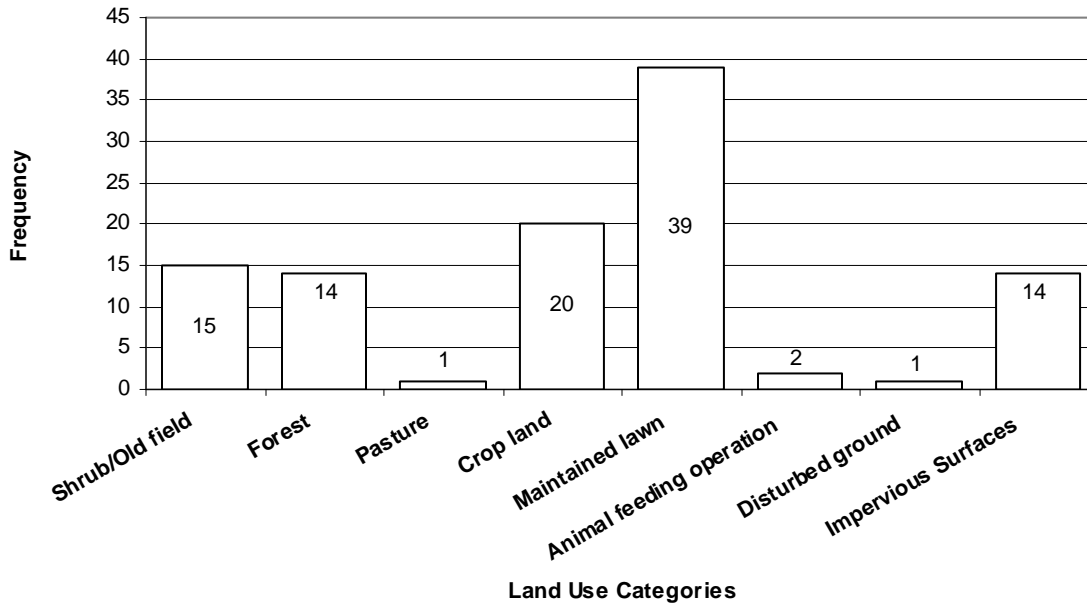
Figure 8. Summary of adjacent land uses

Adjacent land uses were recorded at each survey location for both the upstream and downstream stretches as well as both the right and left banks. Because the entire section of stream that can be seen from the road crossing is evaluated, multiple land uses can be recorded for each site. Land uses within the watershed play an important role in nutrient input, erosion, and in-stream conditions that affect water quality, quantity and habitat. Refer to Attachment B, Table 4 and Figure 8 for a summary of all the adjacent land uses recorded within the watershed. The most common adjacent land uses were maintained lawns, cropland, forest, shrub/old field and impervious surfaces followed by a lesser number of observations for pasture, animal feeding operations and disturbed ground.

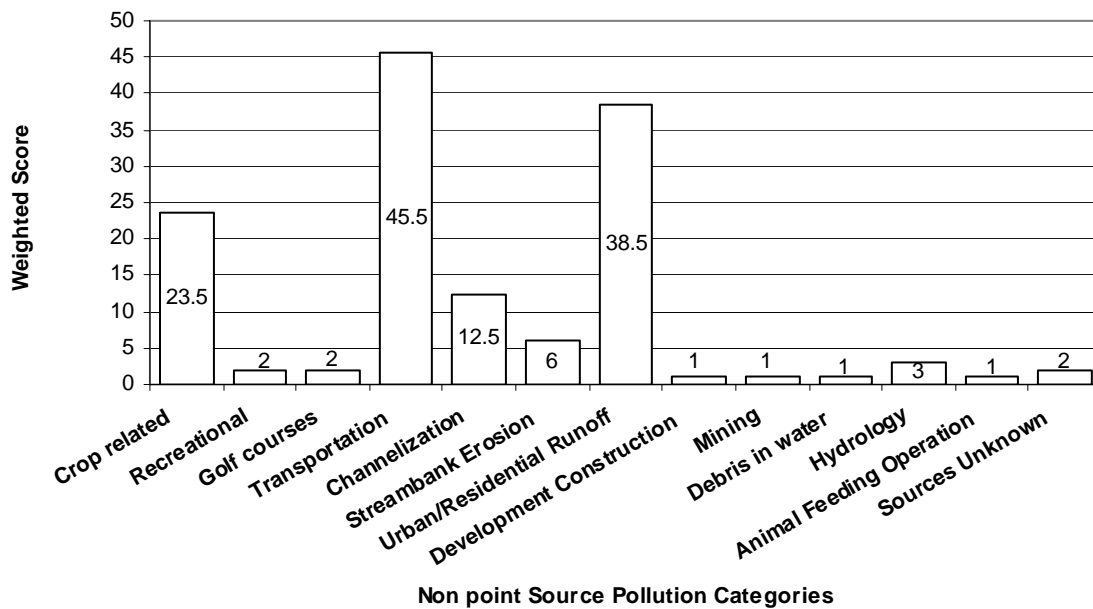
Figure 9. Weighted values for possible sources of non point source pollution (cumulative score for all locations)

During the completion of the road stream crossing surveys, field staff also evaluated the *potential* for non point source pollution. This assessment focuses on the severity of *potential* pollutant *inputs*, not pollutant *impacts*. As part of this evaluation process field staff look for 1.) a possible pollutant source, 2.) a potential pathway to the waterbody and 3.) potential severity of the input. Because each potential source was given a ranking of slight, moderate and high for severity, the values recorded were weighted before they were summed for each category (Refer to Figure 9, Attachment B). Observations recorded as slight were considered to be the basis for comparison, therefore observations recorded as moderate were multiplied by 1.5 and observations recorded as high were multiplied by 2. Potential non point source pollution from transportation, crop related sources and urban residential runoff were the most serious while streambank erosion, channelization and hydrology were also considered common sources of NPS pollution. Refer to Table 5 in Attachment B for a summary of the non point source pollution observations identified for each survey location.
