Lake Creek Watershed

Ionia County, MI

Field Surveys
performed by DEQ staff
August 2003

SUMMARY OF LAKE CREEK WATERSHED ASSESSMENT IONIA COUNTY, MICHIGAN

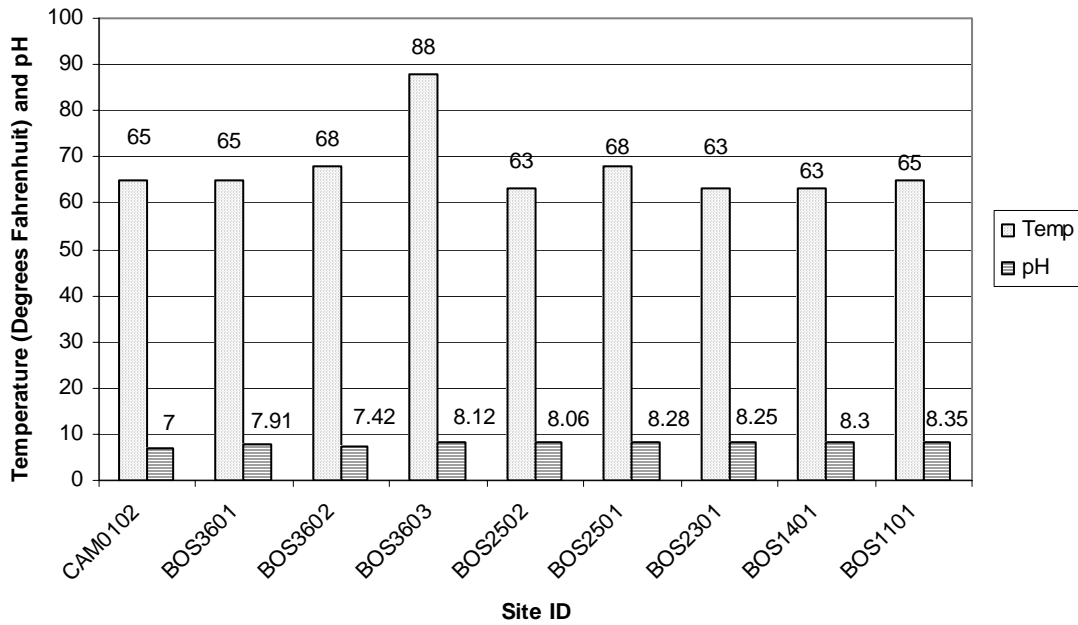
Figure 1. Temperature and pH summary for the Lake Creek Watershed

Survey locations were assessed in the order of upstream sites (in the headwaters) to downstream sites (towards the mouth). Nine locations, including five on the main stem of Lake Creek, were measured for temperature and pH. pH values ranged from 7.0 to 8.35, and were not outside of the normal range for streams in Michigan. Overall the average temperature was 67.5° F, with most stations at either 63° or 65° F. One location, at Portland Road, near the Morrison Lake Country club golf course was 88°F. This comparatively high reading was evidently the result of thermal pollution resulting from nearly stagnant waters flowing through a golf course which provided no riparian vegetation, and therefore no stream canopy shading the channel.

Normal stream temperatures capable of supporting a coldwater fishery with few diseases are below 57°F. Walleye, northern pike and some trout are adapted to temperatures between 57° to 68°F while temperatures over 68°F are characteristic of fish communities containing bass, crappie, bluegill, carp and sucker, with occurrence of fish disease high. Note that the maximum air temperature on the day the survey was conducted was 86°F. Refer to Figure 1 in Attachment B, which depicts the temperature and pH levels at all

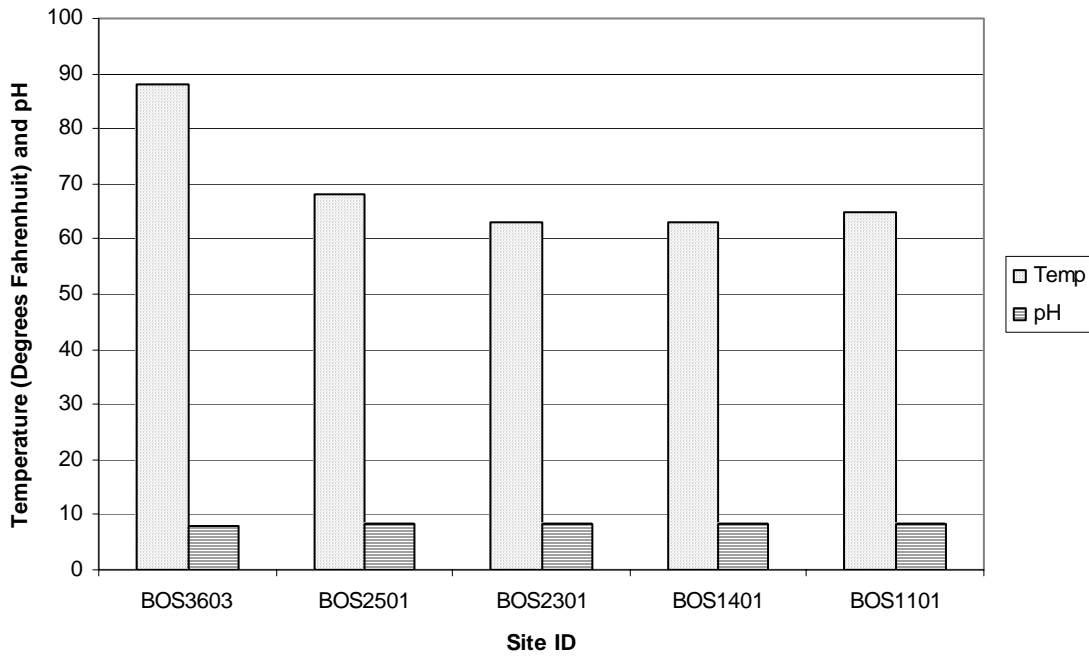
Figure 2. Temperature and pH summary for the mainstem sample locations from the headwaters to the mouth

locations surveyed and to Figure 2, for only those temperatures and pH measurements for the mainstem locations.

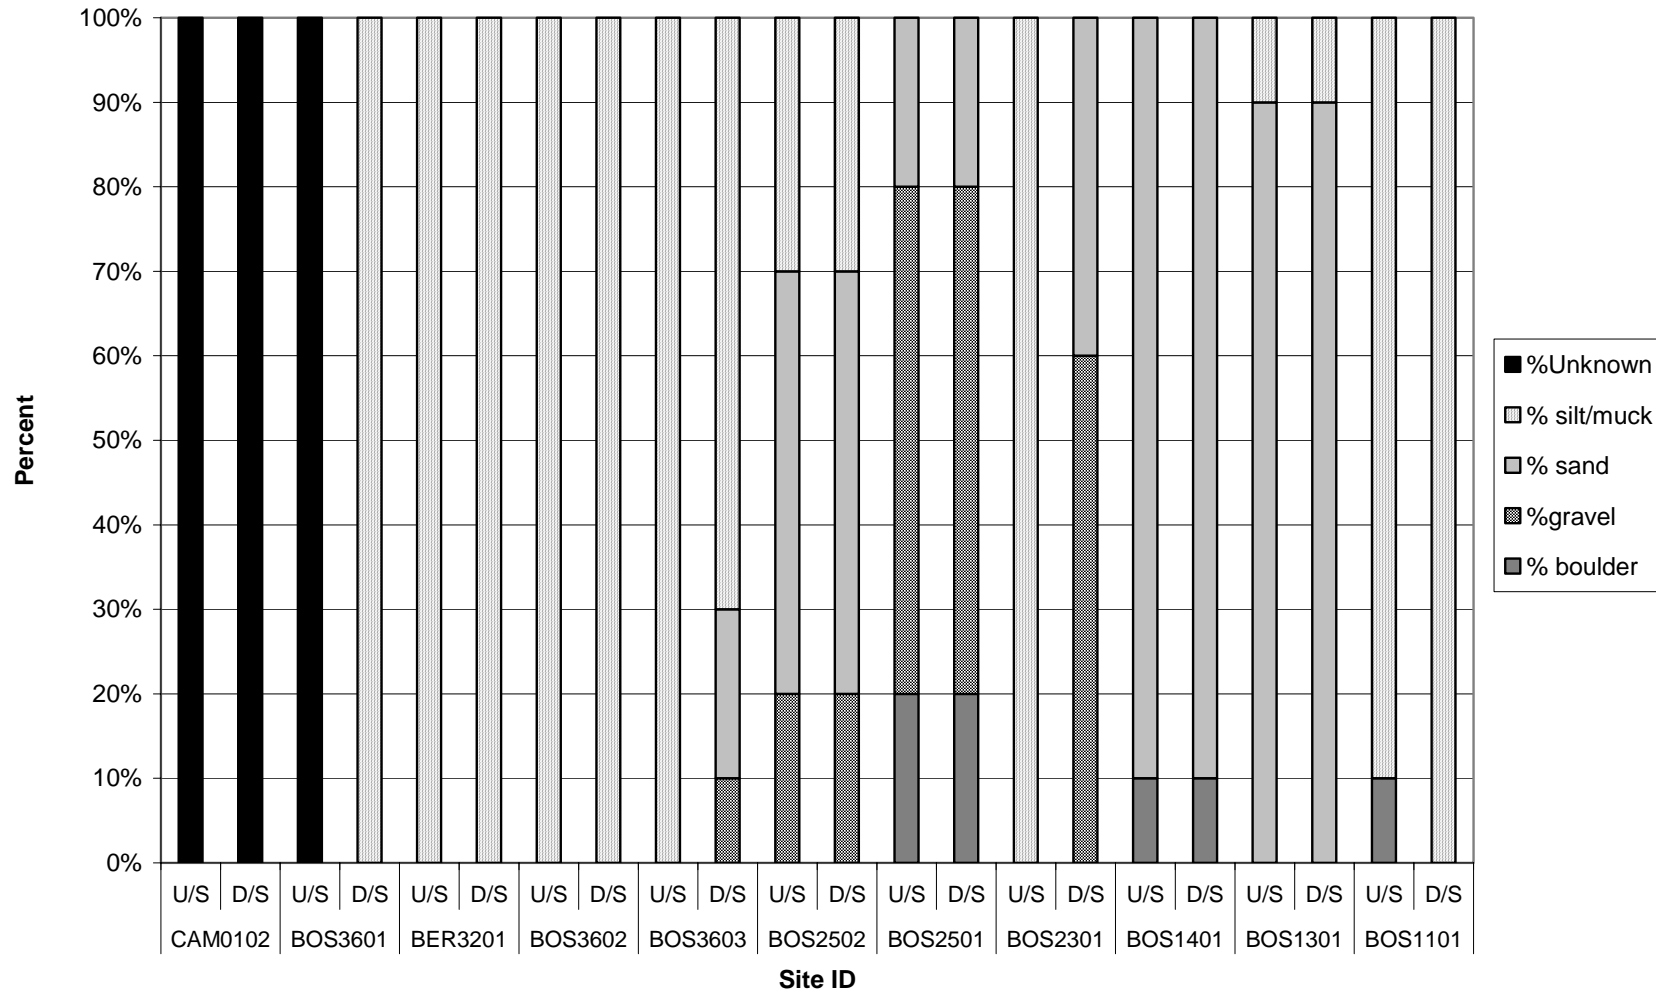
Figure 3. Percent substrate observation for each sample location

Substrate was observed and quantified for both the upstream and downstream stretch at each survey location. In all, 22 substrate observations were recorded. Substrate type is important when considering habitat suitability for desired species within the system (i.e. trout and other fish species). Cobble and gravel substrates with a low degree of embeddedness are the most suitable for reproduction in many fish species. Evidence of silt and sand dominated substrate could indicate problems within the watershed such as erosion and sedimentation. Among the survey locations within the Lake Creek Watershed approximately 18% were dominated (80 to 100% covered by) sand and 41% were dominated by silt, detritus or muck. None of the sites observed appeared to be dominated by cobble or gravel, however 40% of the sites had some amount of gravel present. Refer to Figure 3, in Attachment B, for a graph depicting the substrate composition at each survey location.

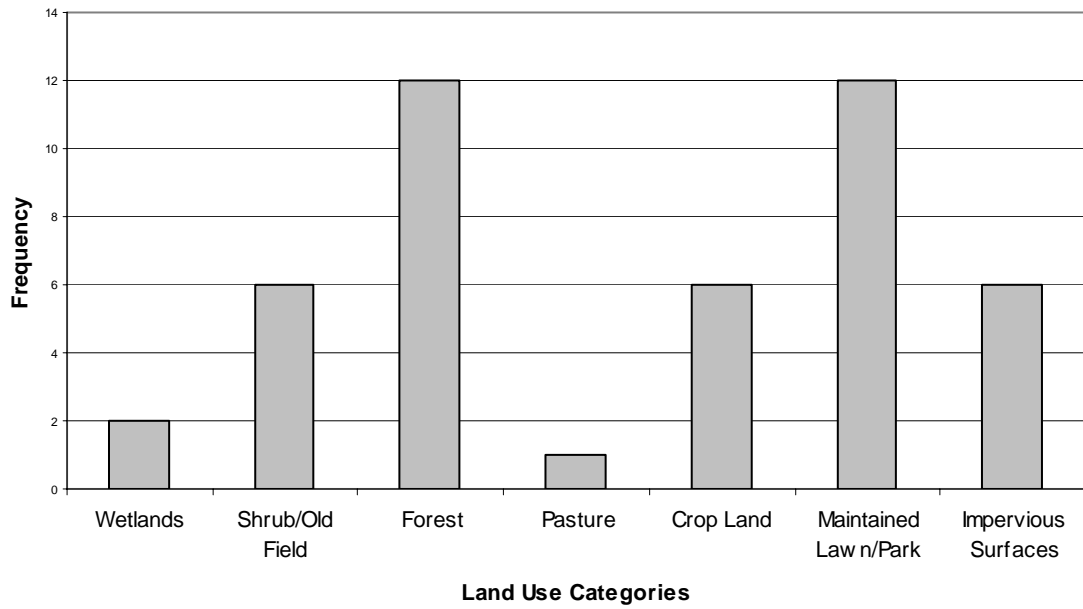
Figure 4. Summary of adjacent land uses

Adjacent land uses were recorded at each survey location for both the upstream and downstream stretches as well as both the right and left banks. Because the entire section of stream that can be seen from the road crossing is evaluated, multiple land uses can be recorded for each site. Land uses within the watershed play an important role in nutrient input, erosion, and in-stream conditions that affect water quality, quantity and habitat. Refer to Attachment B, Table 4 and Figure 4 for a summary of all the adjacent land uses recorded within the watershed. The most common land uses were maintained lawn and forest followed by an equal number of observations for shrub/old field, cropland and impervious surfaces.

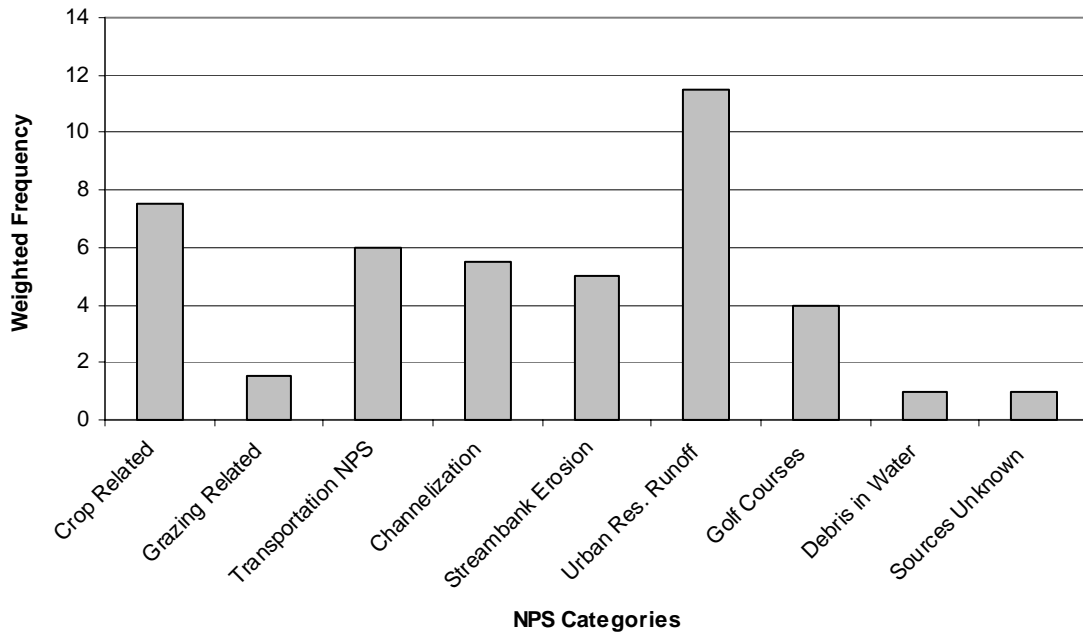
Figure 5. Weighted Values for Possible Sources of NPS Pollution

During the completion of the road stream crossing surveys, field staff also evaluated the *potential* for non point source pollution. This assessment focuses on the severity of *potential* pollutant *inputs*, not pollutant *impacts*. As part of this evaluation process field staff looks for 1.) a possible pollutant source, 2.) a potential pathway to the waterbody and 3.) potential severity of the input. Because each potential source was given a ranking of slight, moderate and high for potential severity, the values that were recorded were weighted before they were summed for each category (Refer to Figure 5, Attachment B). Observations recorded as slight were considered to be the basis for comparison, therefore observations recorded as moderate were multiplied by 1.5 and observations recorded as high were multiplied by 2. Potential non point source pollution from urban residential

runoff and crop related sources were the most serious while streambank erosion, transportation NPS, and channelization were also considered common sources of NPS pollution. Refer to Figure 5 in Attachment B for a summary of the non point source pollution observations identified for each survey location.
